Field monitoring of soil-moisture to understand the hydrological response of a road-cut slope

Samprada Pradhan^{1*}, David G. Toll¹, Nick J. Rosser¹, and Matthew J. Brain¹

Abstract. Rainfall and slope-cutting for road construction are two key landslide causative factors in Nepal, but how they interact to cause failures is poorly understood. To improve understanding of the effects of cut slopes during rainfall, geotechnical investigations and field monitoring were conducted in a mountainous district, Sindhupalchowk, located in central Nepal. This paper presents the results of the field-investigations and the measurements of volumetric water content obtained from the sensors installed in the study-site. Field-based evidence suggests that the slope that was cut for road construction during the dry period remained stable due to the presence of soil suction, which imparted additional strength to the soil. At the start of the monsoon, infiltration of rainwater caused saturation of the soil at shallow depth, consequently causing loss of suction and reduction of the soil strength. The presence of the road-cut in the hillslope resulting in steeper slopes then promoted the failure. These o

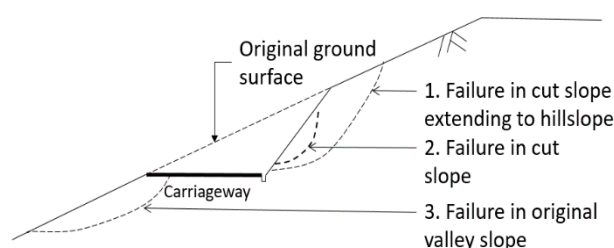
Fig. 2 Major failure types along Daklang-Listi Road (modified after [11])

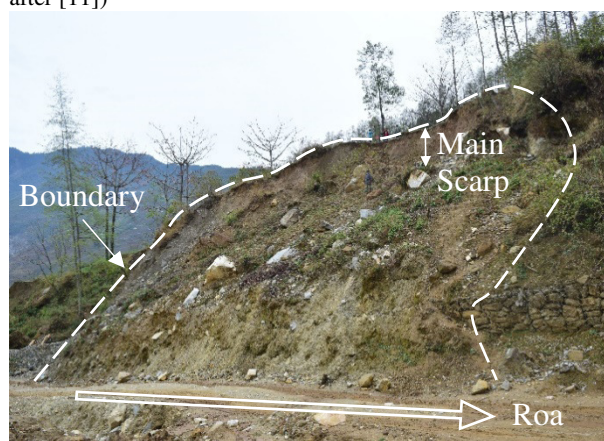
Fig. 3 Photograph of the Kanglang landslide

Length	25 m
Width	45 m
Depth of sliding surface	~1.5 m
Failure type	Translational slide [12]
Aspect	North-east
Elevation	1442 m to 1463m
Cut slope angle	~70°
Hillslope angle	~23°

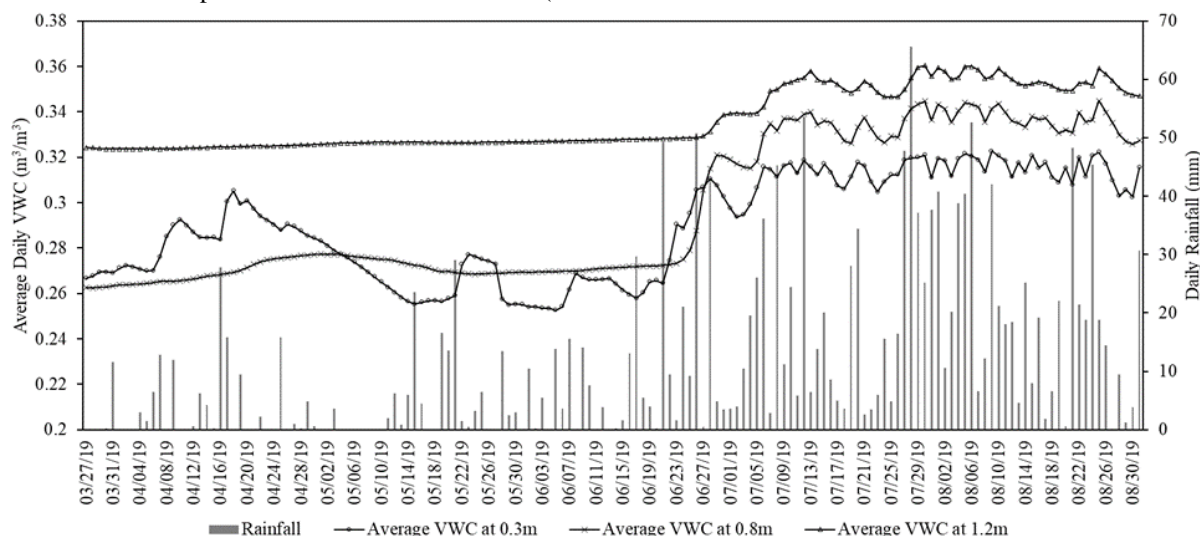
Fig. 6 presents the rainfall and average daily VWC measurements from 28 March to 31 August 2019. There exist notable differences in the response of the sensors located at different depths below the ground surface during this period.

The fluctuations in the VWC at 0.3 m was found to be directly connected to the amount of rainfall. The VWC at this layer responded quickly during and after the rainfall event, which can be attributed to the presence of surficial cracks that dominate the hydraulic conductivity of the soil near the surface. In contrast, the VWC at 1.2 m depth remained almost constant (<1%

Fig. 6 Average daily VWC (m^3/m^3) and daily rainfall (mm) between 27 March 2019 and 31 August 2019.

The variations in the daily rainfall and average daily VWC from June until the end of August 2019 are shown in Fig. 6. From the beginning of monitoring until 31 August 2019, 1840 mm rainfall was recorded, 85% of which occurred after 1 June 2019. Due to the heavy rainfall and consecutive wet days, changes in the VWC down to 1.2 m were recorded.

In the case of Kanglang landslide in July 2018, slope-cutting for road was carried out during the dry season. Due to the additional shear strength imparted by soil suction during this period, the slope may have remained stable. As observed during the 2019 monsoon (Fig. 6), rainfall infiltration in July 2018 caused increase in the VWC and hence a loss of suction can be expected in the soil layers below 1.2 m. This loss of suction, and hence loss of shear strength, consequently could lead to failure.

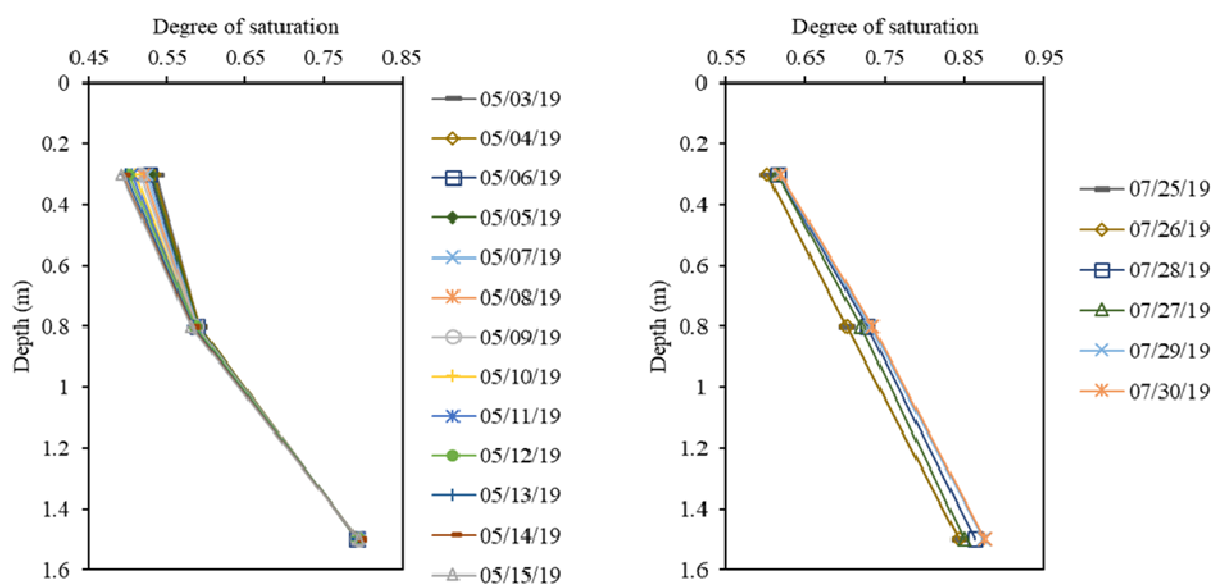
Fig. 7 (a) Variations in the degree of saturation from 3 May 2019 to 15 May 2019 (13 days), (b) Variations in the degree of saturation from 25 July 2019 to 30 July 2019 (6 days)

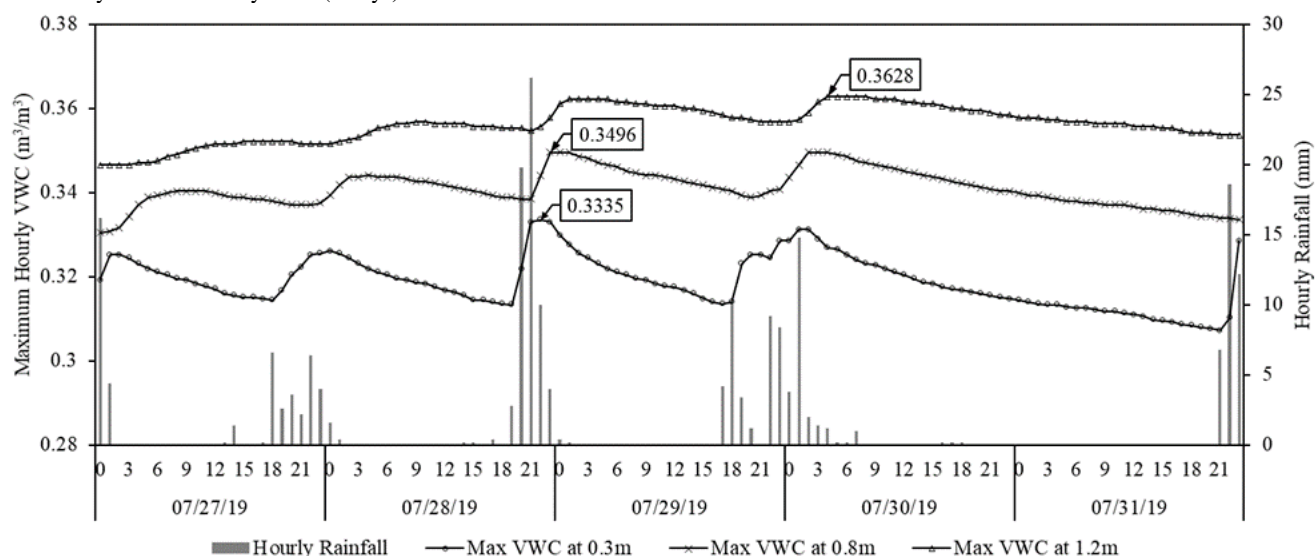
Fig. 8. Maximum hourly VWC (m^3/m^3) and hourly rainfall (mm) between 27 July 2019 and 31 July 2019

Moreover, Fig. 8 highlights the pattern of the increasing response-time of VWC with depth. In general, decrease in the VWC at the upper layer is followed by increase in the VWC at the underlying layer. Such temporal variations of the VWC increments represent the infiltration pattern in the soil. If such conditions prevail throughout the depth of the soil, the decrease in the VWC at 1.2 m on 30 July 2019 after reaching the maximum value shall be followed by a rise in the VWC in the underlying layers. This means that the soil layer below 1.2 m can have a VWC greater than 0.363 m³/m³. Since the porosity of the soil at 1.5 m is 36.40%, the soil at this layer may have reached complete saturation on 30 July 2019.
